Troubleshooting

Diagnosis procedure of each symptom

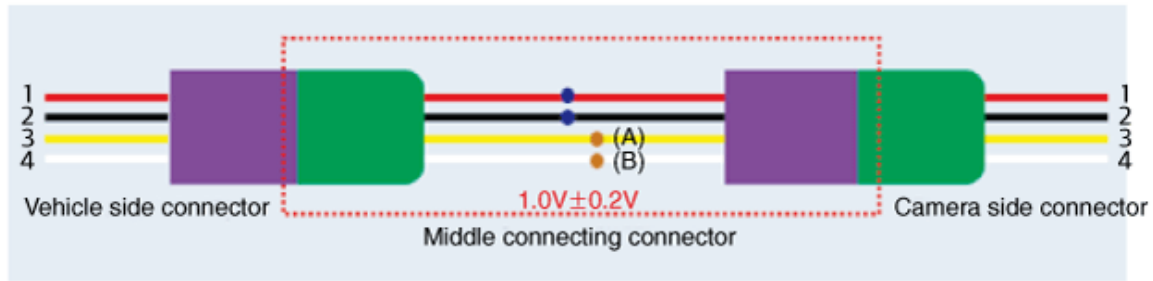
1. Measure the video display waveform and output voltage of rear camera (using KDS VMI).  
Connect connector 3 - connector 4.

– Spec : 0.8V ~ 1.2V

<Normal waveform>

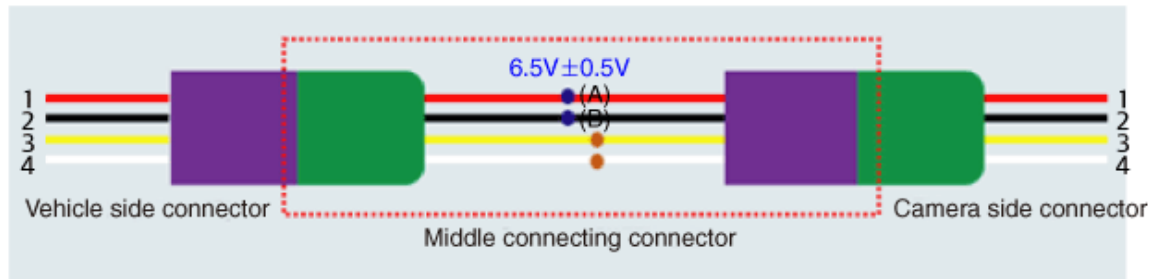
2. Measure the output voltage of rear camera power source.  
Connect connector1-connector2.

– Spec : 6.0V ~ 7.0V

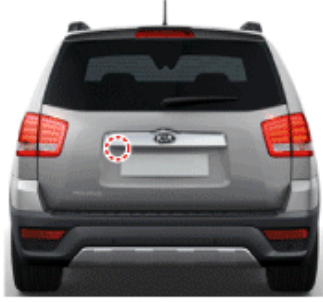
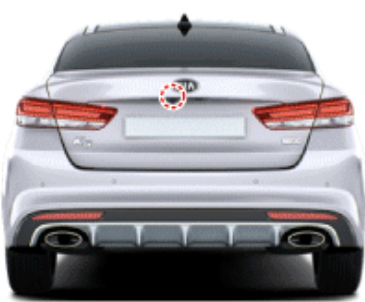
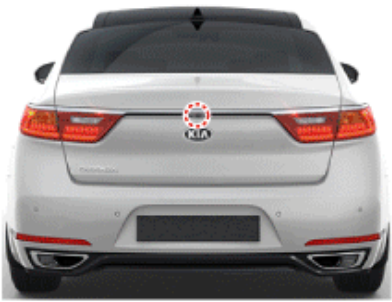
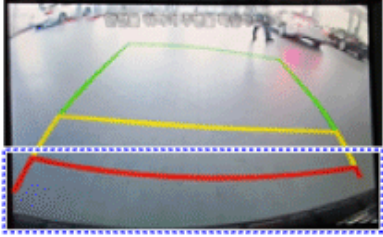
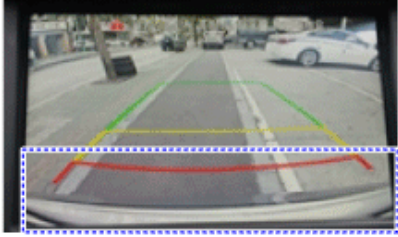
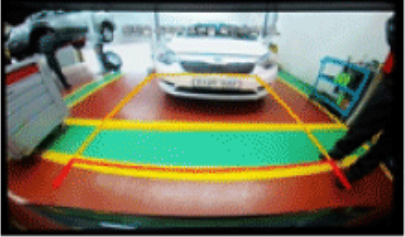
#### R-4. Check the symptom related to place of camera installation

| Install the camera on left side | Install the camera on left side of tail gate switch in center | Install the camera on the center |
|---|---|---|
| Visible camera angle and parking line have been slanted | Difference on amount of visible bumper and length of parking line | equal amount of visible left/right side |
| Normal | Normal | Normal |

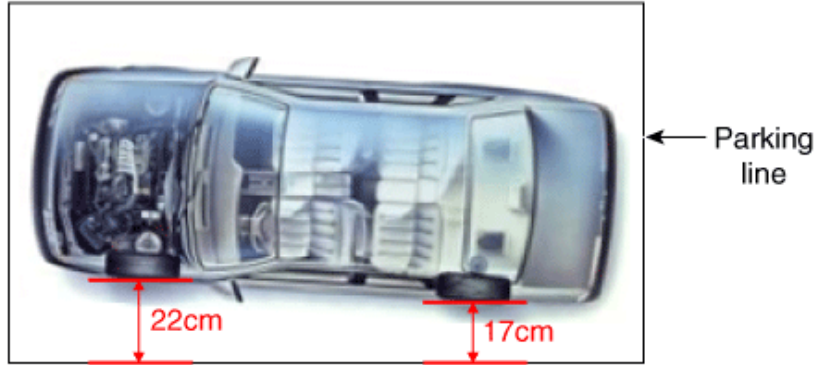
- Check the different distance between front/rear wheel and parking line.

It is normal range that front wheel/  
rear wheel have been slanted in 5cm.

- Being slanted and leaned can be happened depending on driver.
