## Troubleshooting

### Diagnosis procedure of each symptom

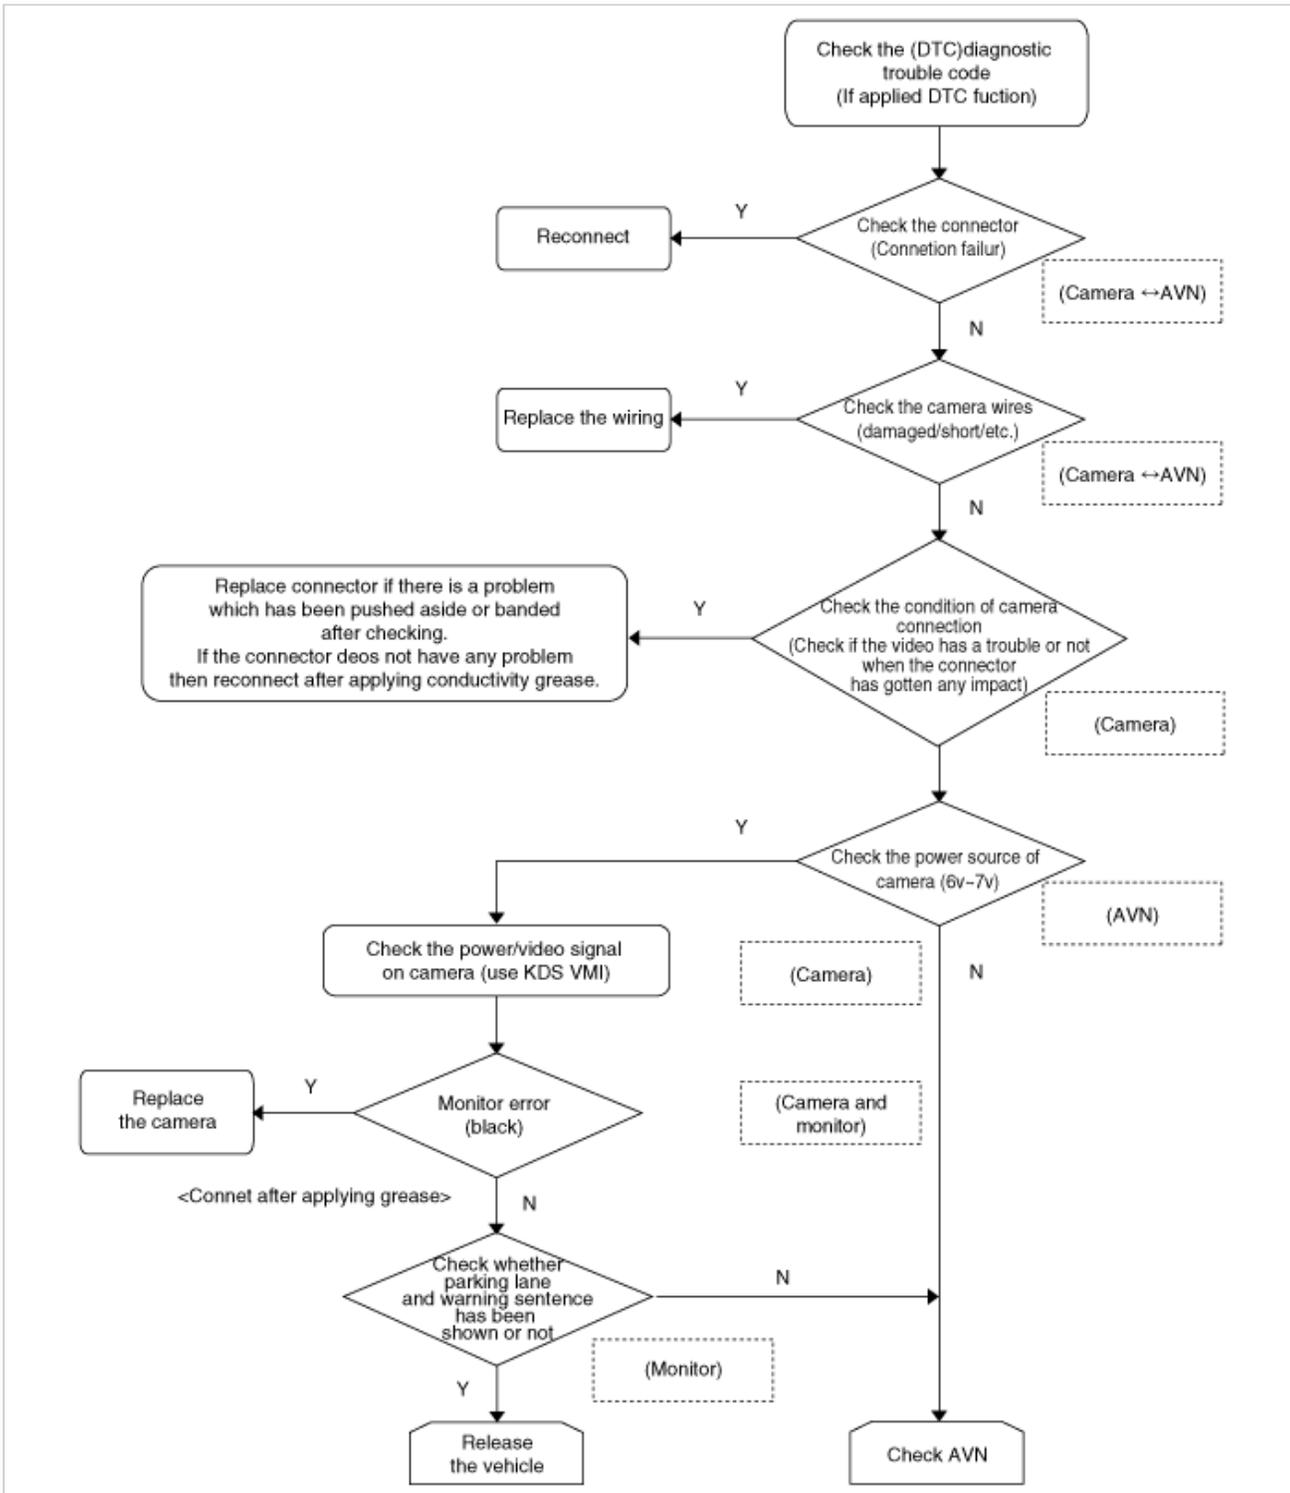
**R-1. Inspect in following order when black screen has been occurred(camera - AVN direct connection specification)**

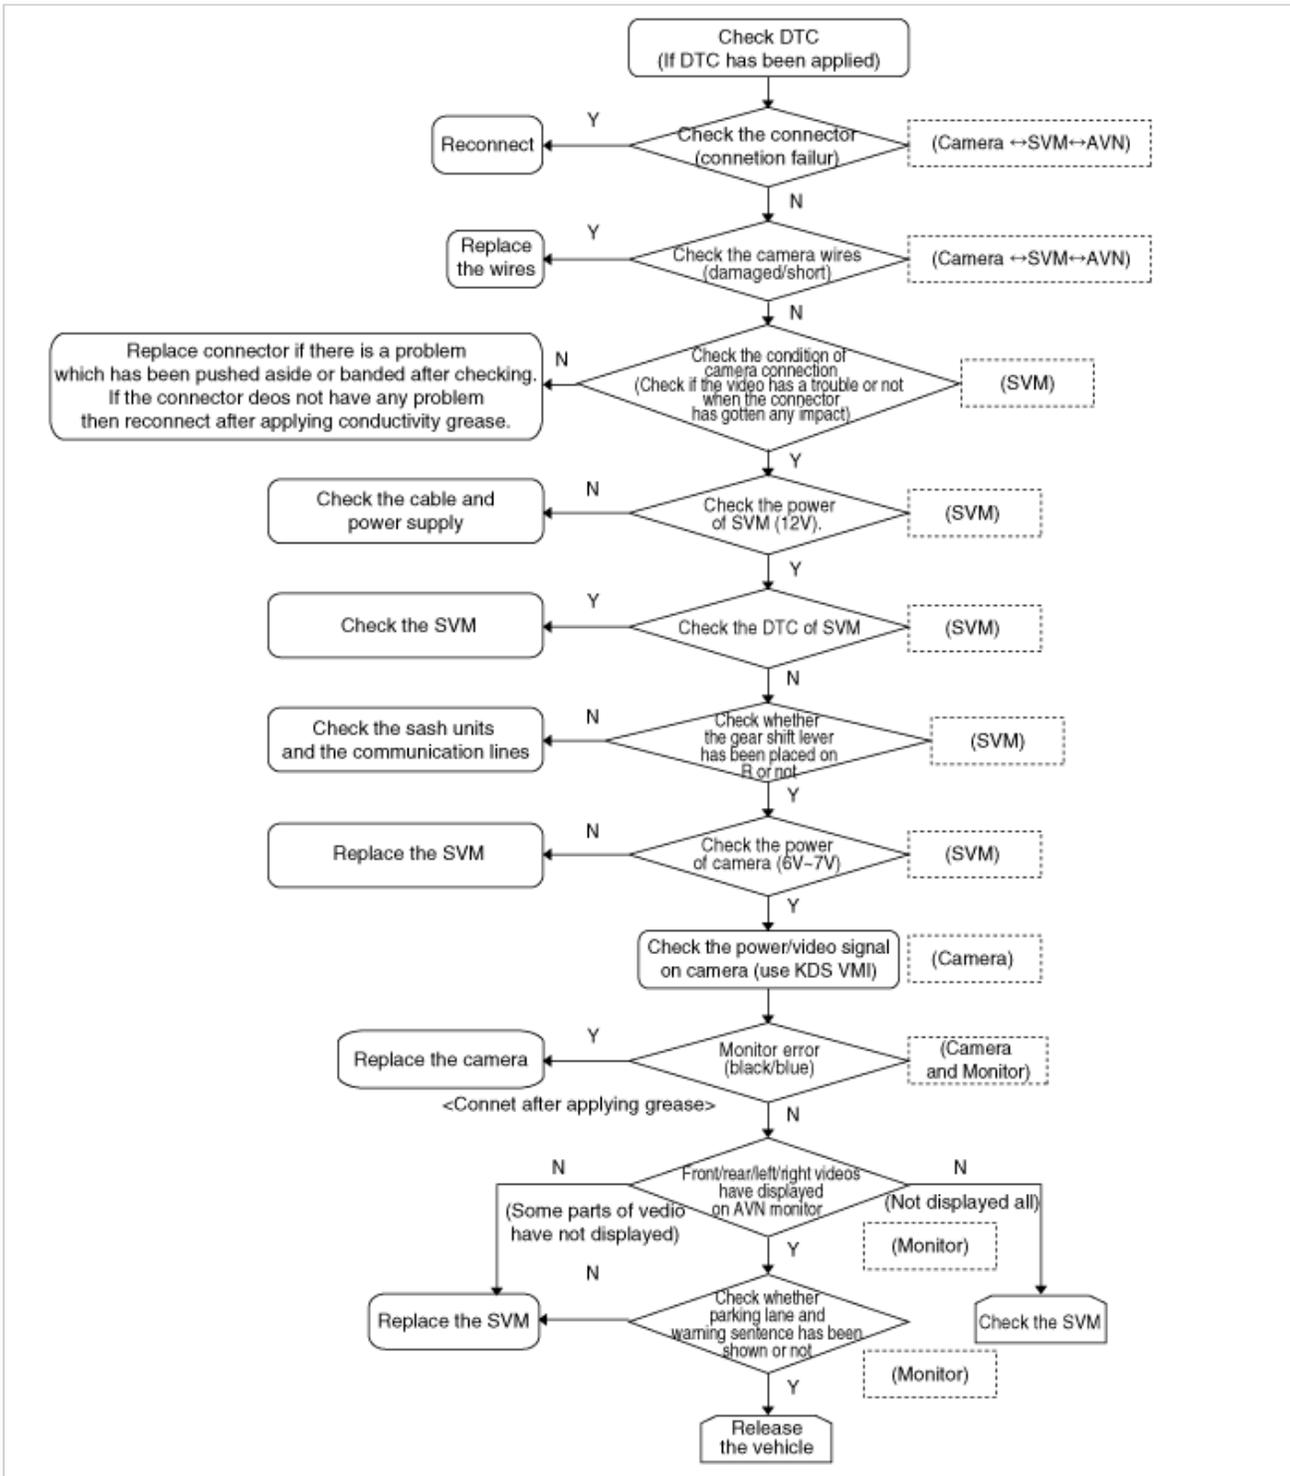
R-2. Inspect in following order when the screen turns to black/blue (camera - PGS/SVM - AVN specification)

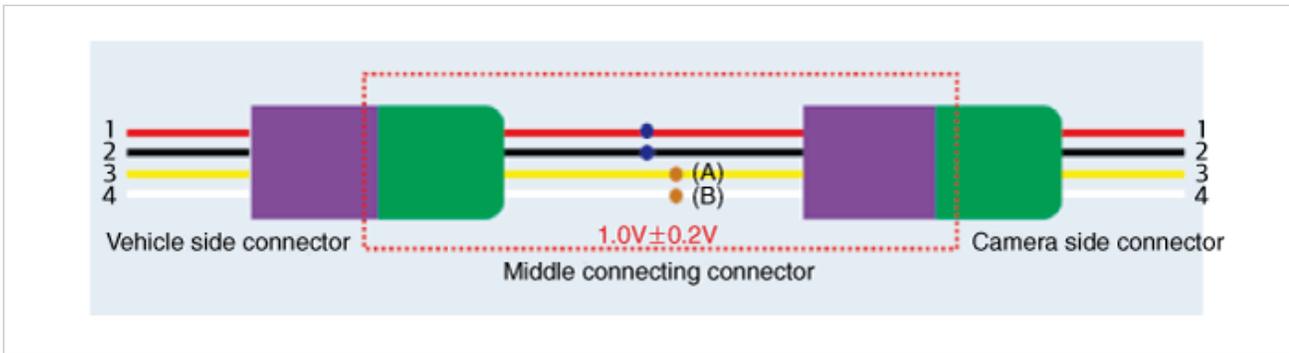
1. Measure the video display waveform and output voltage of rear camera (using KDS VMI).  
Connect connector 3 - connector 4.

- Spec : 0.8V ~ 1.2V

Connector	No.	Option	Description	Color
	1	Standard (4pins)	Power of camera supply (+)	Red
	2		Power of camera grounding (-)	Black
	3		Video display output (+)	Yellow
	4		Video display grounding (-)	White
	5	Steering (6pins)	C_CAN HIGH	Orange
	6		C_CAN LOW	Gray

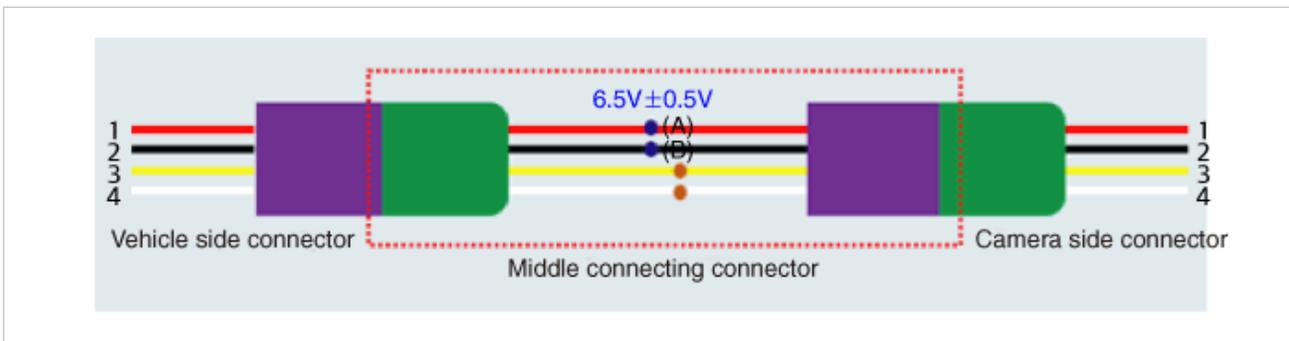
2. Measure the output voltage of rear camera power source.  
Connect connector1-connector2.

- Spec : 6.0V ~ 7.0V

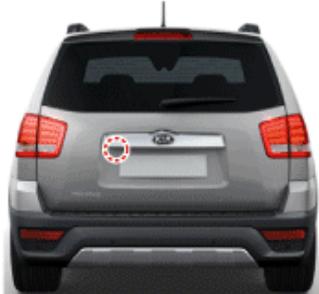
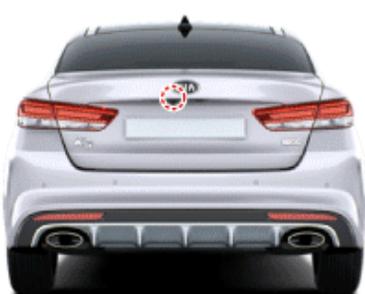
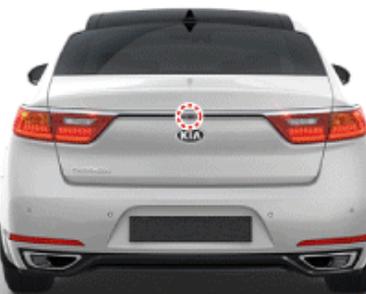
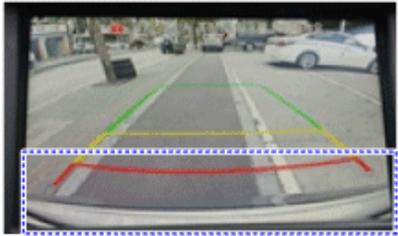
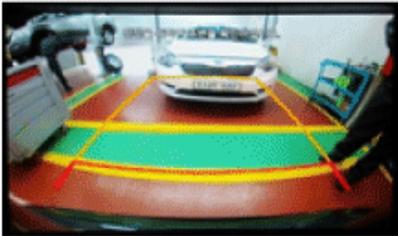
#### R-4. Check the symptom related to place of camera installation

Install the camera on left side	Install the camera on left side of tail gate switch in center	Install the camera on the center

<p>Visible camera angle and parking line have been slanted</p>	<p>Difference on amount of visible bumper and length of parking line</p>	<p>equal amount of visible left/right side</p>
<p>Normal</p>	<p>Normal</p>	<p>Normal</p>

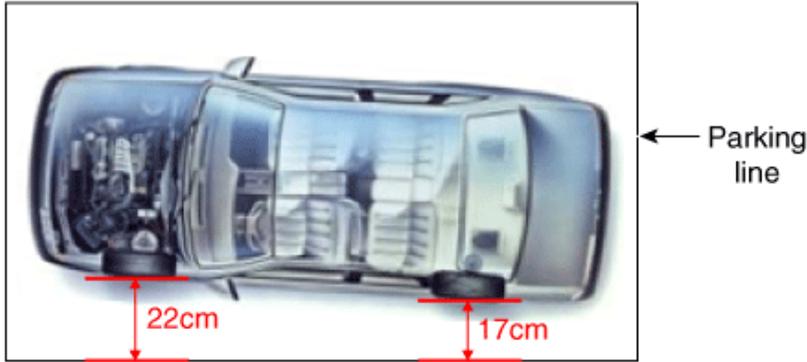
- Check the different distance between front/rear wheel and parking line.

It is normal range that front wheel/  
rear wheel have been slanted in 5cm.

- SPEC : ± 10cm (Front Wheel-Rear Wheel)
