## REMOVAL

## DISASSEMBLY

## REASSEMBLY

## INSPECTION

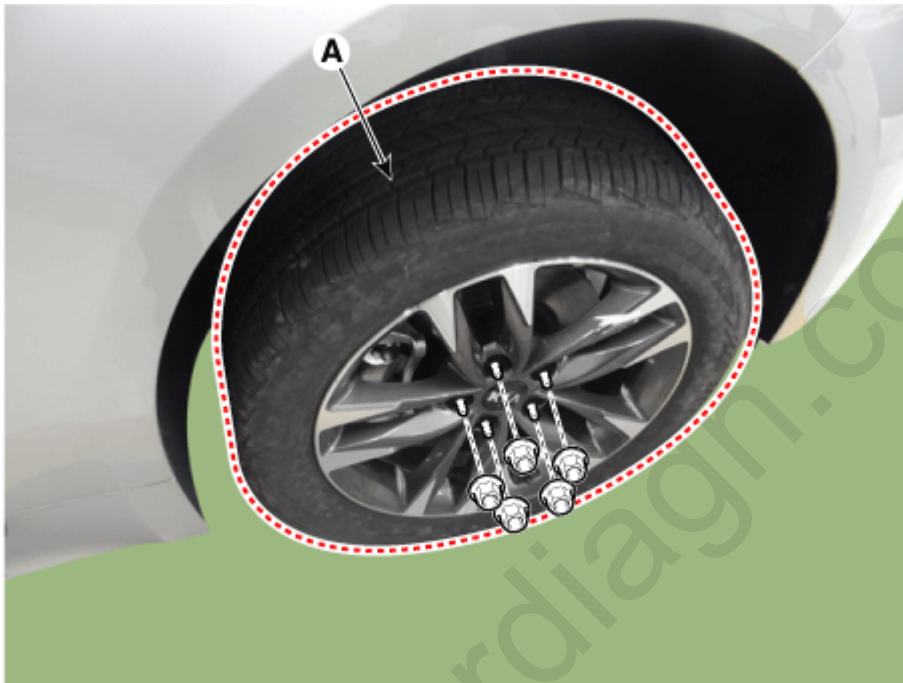
1. Remove wheel nuts, wheel and tire (A) from hub.

#### Tightening torque:

107.9 - 127.5 N·m (11.0 - 13.0 kgf·m, 79.6 - 94.0 lb·ft)

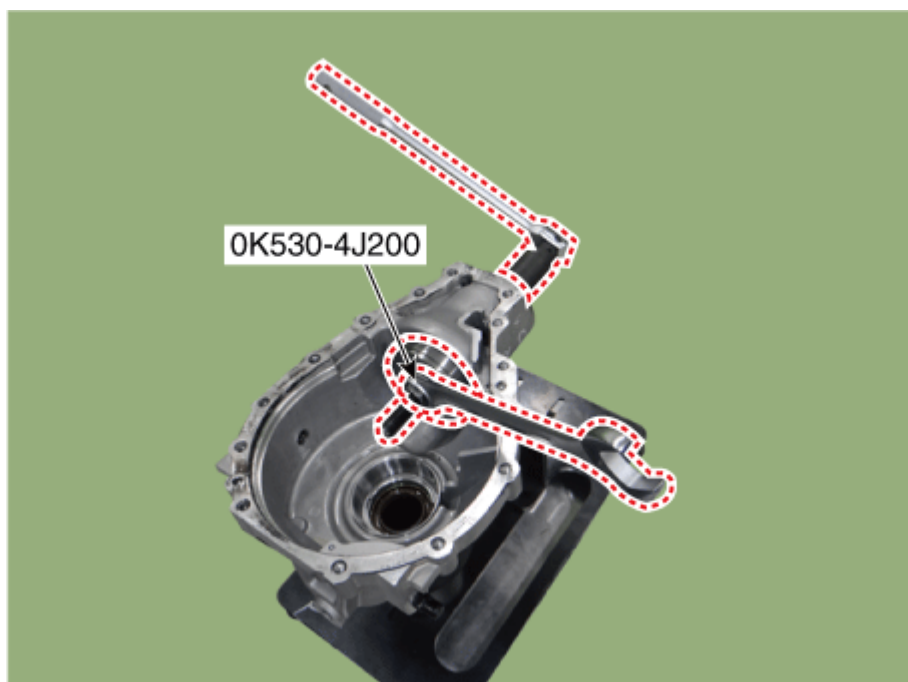
2. Using the SST (0K530-4J200), install the rear pinion bearing outer race (A).

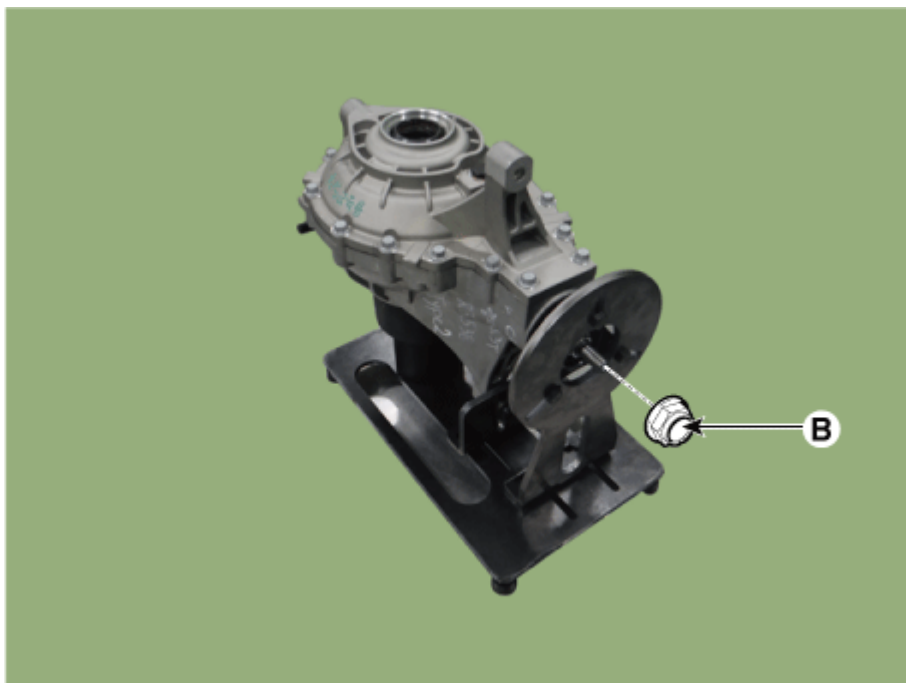
9. Using the SST (0K530-4J100), fix the companion flange (A) and then install the nut (B).

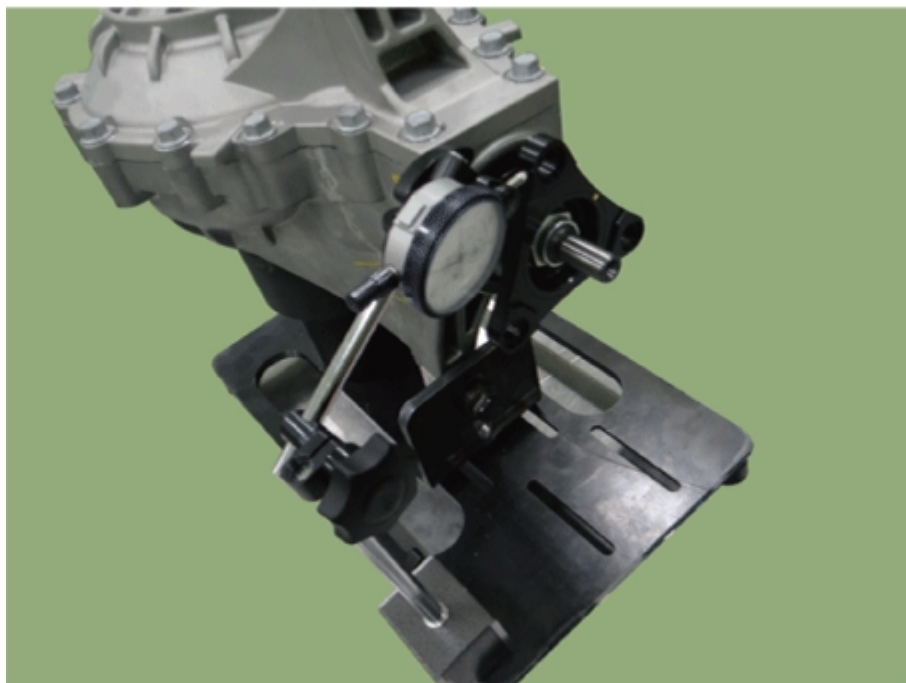
8. Measure the back rash from the companion flange.

**Backlash :** Below 0.6°

- Measure the backlash by applying the torque of 30kgf.cm to the companion flange in both directions.
- The thickness of both spacers shall be adjusted by disassembling again when the backlash is bigger or smaller than the tolerance.
- Increase the spacer thickness on the cover side by one unit and reduce the spacer thickness on the carrier side by one unit when backlash is bigger than the tolerance.
- Increase the spacer thickness on the carrier side by one unit and reduce the spacer thickness on the cover side by one unit when backlash is smaller than the tolerance.
- The adjusting unit of the spacer is 0.02mm.
